**Flood Control Project Maintenance
Levee Inspections**

Maintenance Issue Types Only, Levee Inspection Report By Mile - Fall 2019

Sutter Maintenance Yard Maintenance Area 0001

Waterway	Bank	Unit Miles	Inspection Start/End	Inspector
Unit No. 01 Sacramento River	Right	16.76	10/15/2019 10/15/2019	Makar Sokol

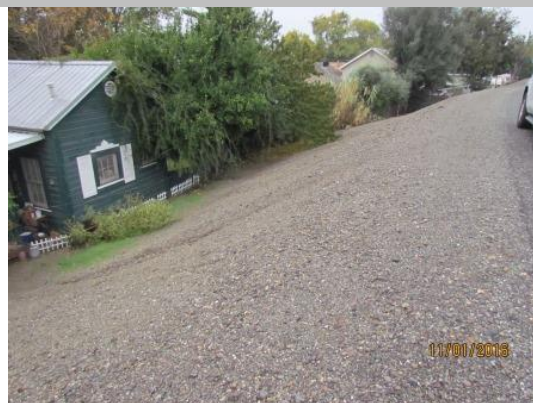
Photo 1 of 1 : FA_2019_MA0001_297_94_20190822_00026.jpg

LM Start	0.09	Rating **	A/W	Issue No.	94
LM End	0.09	Issue Type +	Ma	Location *	LS
Category	Earthen Levee			GPS Latitude/Longitude	
				Start	End
Item	Slope Stability			39.214217 °	39.214217 °
				-122.002378 °	-122.002378 °
DWR ID	DWR_MA0001_01_f_2016_94				
Comment Code					
S2 : Repair the levee slope damaged by foot traffic and prevent access where possible.					
Inspector Comment

View of the slope instability along the landside slope.

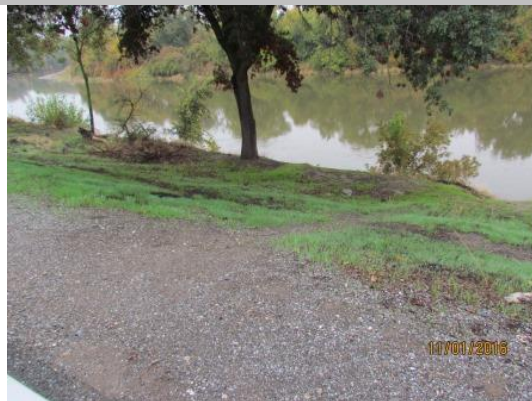
Photo 1 of 1 : FA_2019_MA0001_297_98_20190822_00028.jpg

LM Start	0.38	Rating **	A/W	Issue No.	98
LM End	0.38	Issue Type +	Ma	Location *	WS
Category	Earthen Levee			GPS Latitude/Longitude	
				Start	End
Item	Slope Stability			39.215878 °	39.215878 °
				-122.007278 °	-122.007278 °
DWR ID	DWR_MA0001_01_f_2016_98				
Comment Code					
S2 : Repair the levee slope damaged by foot traffic and prevent access where possible.					
Inspector Comment

View of the slope instability along the waterside slope.

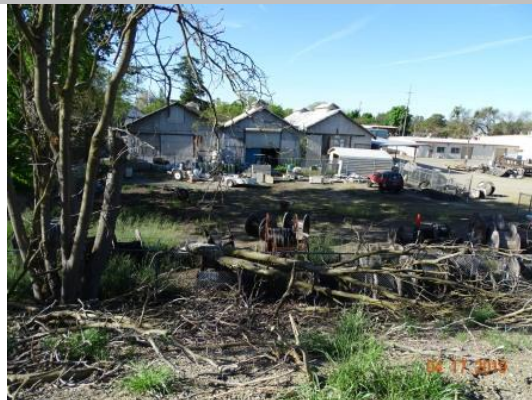
Photo 1 of 1 : FA_2019_MA0001_297_79_20190822_00017.jpg

LM Start	0.87	Rating **	M	Issue No.	79							
LM End	0.87	Issue Type +	Ma	Location *	LS							
Category	Earthen Levee		GPS Latitude/Longitude									
			Start	End								
Item	Encroachments		39.217717°	39.217717°								
			-122.015717°	-122.015717°								
DWR ID	DWR_MA0001_01_s_2019_79											
Comment Code												
TR : Tree or limb												
Inspector Comment

View of the tree branches and limbs at the landside toe. Spring 2019.

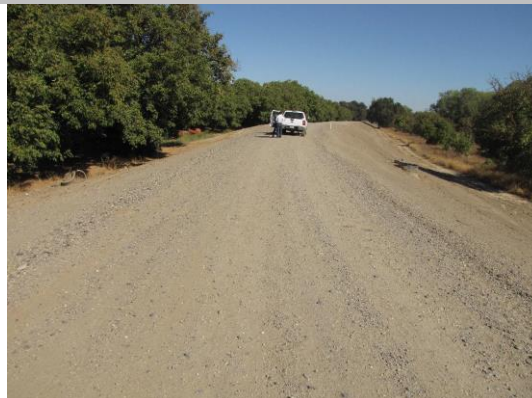
Photo 1 of 3 : UCIP_FA_2019_51852_70064.jpg

DS_ID:16430
FS_ID:51852
EP_NO: 9487
Repair Type: Non-Urgent
Crossing Status: Found
UCIP Comments: 5/3/2017 WS end still partially plugged. (DWR Sutter Yard- A Freitag)10/24/2016 WS end is still partially plugged. (DWR Sutter Yard- A Freitag)4/25/2016 WS pipe end is still plugged with soil. Rest of the pipe appeared to be in good condition.4/20/2015 WS pipe end is plugged about 50% by soil.6/18/2014 Same as last inspection.12/17/2013 Same as last inspection.7/18/2013 WS pipe end has been reformed but is still clogged about 50% by sediment.10/18/2012 Remove dirt and debris in riser. Outlet deformed and blocked over 50%. Debris-round concrete section on landward side. This crossing was listed in the USACE Periodic Inspections as ID# USACE_CESPK_MA1C_2010_p_0116 for crossing outlet deformed and clogged with dirt.
FIELD_STRUCT_DESC: 1 of 2: 36-inch corrugated metal drainage pipe through the levee, approximately 12-15 feet below the crown. Slide gates in corrugated metal pipe (CMP) riser located on the waterside (WS) slope. Pipe daylights on the landside (LS). (36-inch pipe [HLM 1.97] authorized under Automatic Board Order (ABO) issued as Permit No. 9487, 1974 - Jimeno Rancho) [Additional Reference(s): DWR Levee Log, 1992. USACE Sacramento O&M Manual 137, August 1955, (Station 103+18)].

Overview of levee crown and slopes looking upstream towards crossing.

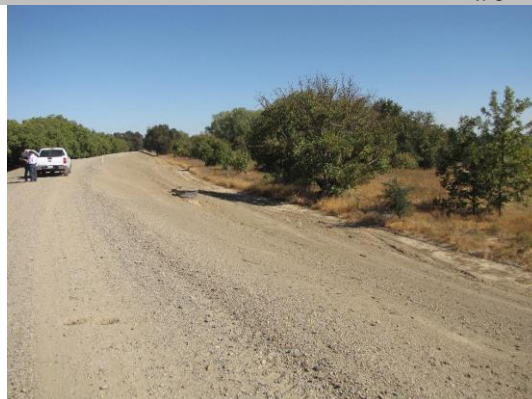
Photo 2 of 3 : UCIP_FA_2019_51852_70063.jpg

View of WS looking upstream at CMP riser on slope.

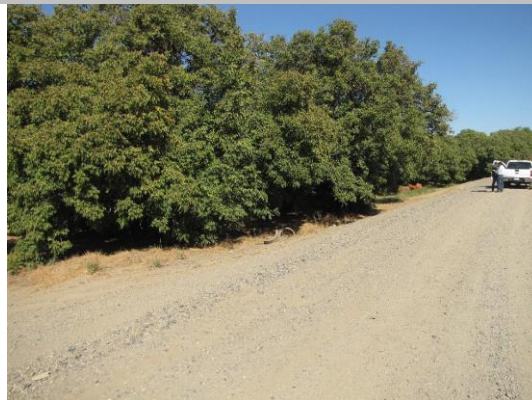
Photo 3 of 3 : UCIP_FA_2019_51852_70062.jpg

Comment Code						
Inspector Comment						
DS_ID:16430 FS_ID:51852 EP_NO: 9487 Repair Type: Non-Urgent Crossing Status: Found UCIP Comments: 5/3/2017 WS end still partially plugged. (DWR Sutter Yard- A Freitag)10/24/2016 Ws end is till partially plugged.(DWR Sutter Yard- A Freitag)4/25/2016 WS pipe end is still plugged with soil. Rest of the pipe appeared to be in good condition.4/20/2015 WS pipe end is plugged about 50% by soil.6/18/2014 Same as last inspection.12/17/2013 Same as last inspection.7/18/2013 WS pipe end has been reformed but is still clogged about 50% by sediment.10/18/2012 Remove dirt and debris in riser. Outlet deformed and blocked over 50%. Debris-round concrete section on landward side. This crossing was listed in the USACE Periodic Inspections as ID# USACE_CESPK_MA1C_2010_p_0116 for crossing outlet deformed and clogged with dirt. FIELD_STRUCT_DESC: 1 of 2: 36-inch corrugated metal drainage pipe through the levee, approximately 12-15 feet below the crown. Slide gates in corrugated metal pipe (CMP) riser located on the waterside (WS) slope. Pipe daylights on the landside (LS). (36-inch pipe [HLM 1.97] authorized under Automatic Board Order (ABO) issued as Permit No. 9487, 1974 - Jimeno Rancho) [Additional Reference(s): DWR Levee Log, 1992. USACE Sacramento O&M Manual 137, August 1955, (Station 103+18)]. FS Date: 5/19/2017 1:20:29 PM

View of LS looking upstream at crossing.

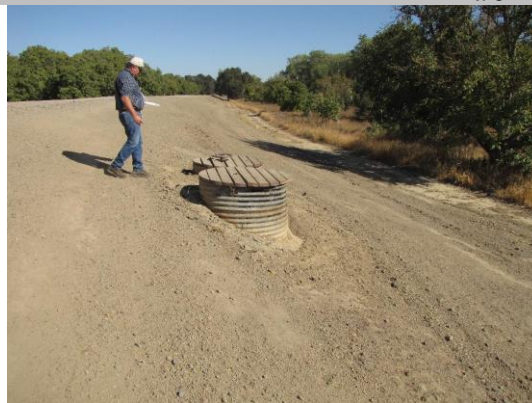
Photo 2 of 3 : UCIP_FA_2019_51853_70074.jpg

View of CMP risers located on WS slope.

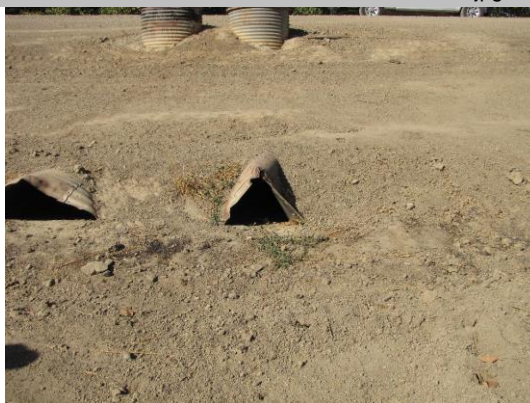
Photo 3 of 3 : UCIP_FA_2019_51853_70073.jpg

Comment Code						
Inspector Comment						
DS_ID:17565 FS_ID:51853 EP_NO: 9487 Repair Type: Non-Urgent Crossing Status: Found UCIP Comments: 5/3/2017 Ws end still partially plugged. (DWR Sutter Yard- A Freitag)10/24/2016 Ws pipe end still plugged.(DWR Sutter Yard- A Freitag)4/25/2016 WS pipe end still plugged with soil. rest of pipe appears in good condition.4/20/2015 WS pipe end plugged about 50% by soil.6/18/2014 Same as last inspection.12/17/2013 Same as last inspection.7/18/2013 WS pipe end has been reformed but is still partially blocked with dirt and debris.10/18/2012 WS-remove dirt and debris in riser. Outlet deformed and blocked over 50%. Burrow activity near outlet on waterward slope. Debris around concrete section on landward side. This crossing was listed in the USACE Periodic Inspections as ID# USACE_CESPK_MA1C_2010_p_0116 for crossing outlet deformed and clogged with dirt. FIELD_STRUCT_DESC: 2 of 2: 36-inch corrugated metal drainage pipe through the levee, approximately 12-15 feet below the crown. Slide gates in corrugated metal pipe (CMP) riser on the waterside (WS) slope. Pipe daylights on the landside (LS). (36-inch pipe [HLM 1.97] authorized under Automatic Board Order (ABO) issued as Permit No. 9487, 1974 - Jimeno Rancho) [Additional Reference(s): DWR Levee Log, 1992. USACE Sacramento O&M Manual 137, August 1955, (Station 103+18)]. FS Date: 5/19/2017 1:21:31 PM

CMP pipe outlet deformed with over 50 percent blockage.

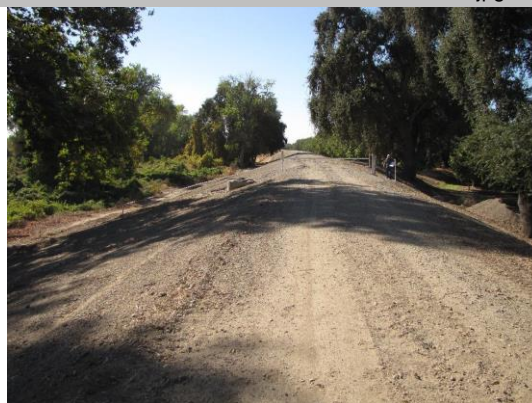
Photo 1 of 3 : UCIP_FA_2019_51854_70078.jpg

Comment Code						
Inspector Comment						
DS_ID:16429 FS_ID:51854 EP_NO: 9472 Repair Type: Non-Urgent Crossing Status: Found UCIP Comments: 5/3/2017 LS inlet partially plugged with soil. Some debris still present inside riser. (DWR Sutter Yard-AFreitag)10/24/2016 Debris still inside of riser.(DWR Sutter Yard-AFreitag)4/25/2016 Pipe still inside of riser and LS end plugged about 50% by soil.4/20/2015 Same as last inspection.6/18/2014 Same as last inspection.12/17/2013 Same as last inspection.7/18/2013 Same as last inspection.10/18/12 Remove debris from riser. Landward inlet is blocked by over 50%. This crossing was listed in the USACE Periodic Inspections as ID# USACE_CESPK_MA1C_2010_p_0128 for sediment build up at inlet (landward side) and debris inside riser. FIELD_STRUCT_DESC: 54-inch corrugated metal drainage pipe through the levee, approximately 12-15 feet below the crown. Slide gate in corrugated metal pipe (CMP) riser on the waterside (WS) slope. 48-inch CMP at landside (LS) slope. This crossing crosses the levee at an angle. (54-inch pipe [HLM 2.29] authorized under Automatic Board Order (ABO) issued as Permit No. 9472, 1974 - Ballard)) [Additional Reference(s): DWR Levee Log, 1992. USACE Sacramento O&M Manual 137, August 1955, (Station 120+00)]. FS Date: 5/19/2017 1:23:34 PM

View of levee crown looking downstream at crossing. CMP riser located on WS shoulder.

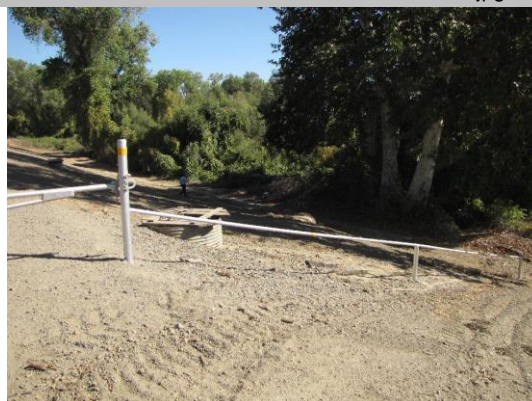
Photo 2 of 3 : UCIP_FA_2019_51854_70079.jpg

Comment Code						
Inspector Comment						
DS_ID:16429 FS_ID:51854 EP_NO: 9472 Repair Type: Non-Urgent Crossing Status: Found UCIP Comments: 5/3/2017 LS inlet partially plugged with soil. Some debris still present inside riser. (DWR Sutter Yard-AFreitag)10/24/2016 Debris still inside of riser.(DWR Sutter Yard-AFreitag)4/25/2016 Pipe still inside of riser and LS end plugged about 50% by soil.4/20/2015 Same as last inspection.6/18/2014 Same as last inspection.12/17/2013 Same as last inspection.7/18/2013 Same as last inspection.10/18/12 Remove debris from riser. Landward inlet is blocked by over 50%. This crossing was listed in the USACE Periodic Inspections as ID# USACE_CESPK_MA1C_2010_p_0128 for sediment build up at inlet (landward side) and debris inside riser. FIELD_STRUCT_DESC: 54-inch corrugated metal drainage pipe through the levee, approximately 12-15 feet below the crown. Slide gate in corrugated metal pipe (CMP) riser on the waterside (WS) slope. 48-inch CMP at landside (LS) slope. This crossing crosses the levee at an angle. (54-inch pipe [HLM 2.29] authorized under Automatic Board Order (ABO) issued as Permit No. 9472, 1974 - Ballard)) [Additional Reference(s): DWR Levee Log, 1992. USACE Sacramento O&M Manual 137, August 1955, (Station 120+00)]. FS Date: 5/19/2017 1:23:34 PM

View of WS looking at slope and channel.

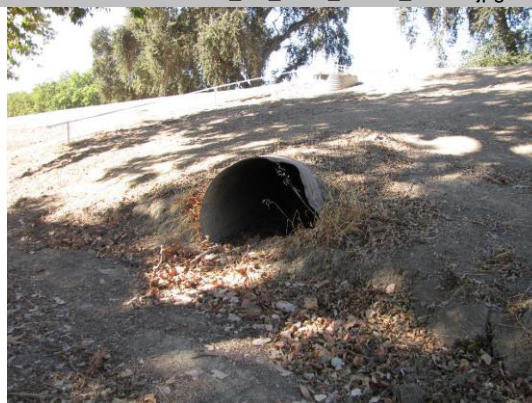
Photo 3 of 3 : UCIP_FA_2019_51854_70077.jpg

View of outlet located at WS toe.

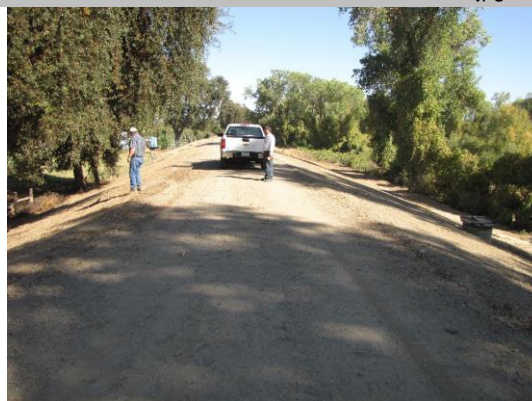
Photo 1 of 3 : UCIP_FA_2019_51855_70085.jpg

Comment Code						
Inspector Comment						
DS_ID:16428 FS_ID:51855 EP_NO: 9467 Repair Type: Non-Urgent Crossing Status: Found UCIP Comments: 5/3/2017 Abandoned- needs to be done so properly. (DWR Sutter Yard- A Freitag)10/24/2016 Abandoned.(DWR Sutter Yard- A Freitag)4/25/2016 Abandoned crossing. Unable to locate any WS and LS pipe ends.4/20/2015 Same as last inspection.6/18/2014 Same as last inspection.12/17/2013 Same as last inspection.7/18/2013 Same as last inspection.10/18/2012 Only riser visible. Debris and sediment blocking gate. Gate inside riser is buried and non-functional. If crossing is abandoned, owner needs to properly abandon. This crossing was listed in the USACE Periodic Inspections as ID# USACE_CESPK_MA1C_2010_p_0132 no culvert through the levee is visible here. FIELD_STRUCT_DESC: *ABANDONED* 24-inch corrugated metal drainage pipe through the levee, approximately 12-15 feet below the crown. Slide gate in CM pipe riser on the waterside (WS) slope. No signs of inlet visible on the landside (LS). (24-inch pipe [HLM 2.31] authorized under Automatic Board Order (ABO) issued as Permit No. 9467, 1974 - Lovell E. Spurgeon) [Additional Reference(s): DWR Levee Log, 1992. USACE Sacramento O&M Manual 137, August 1955, (Station 120+60)]. FS Date: 5/19/2017 1:48:04 PM

Overview of levee crown looking upstream at crossing.

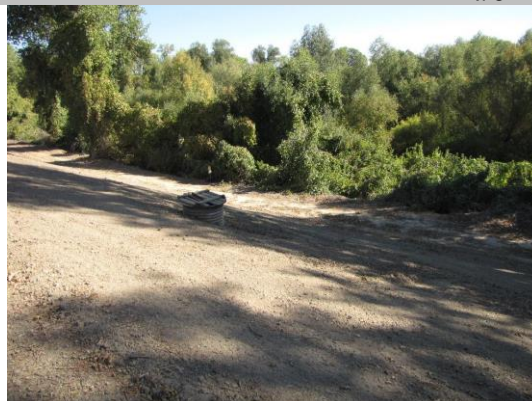
Photo 2 of 3 : UCIP_FA_2019_51855_70084.jpg

View of WS slope and toe.

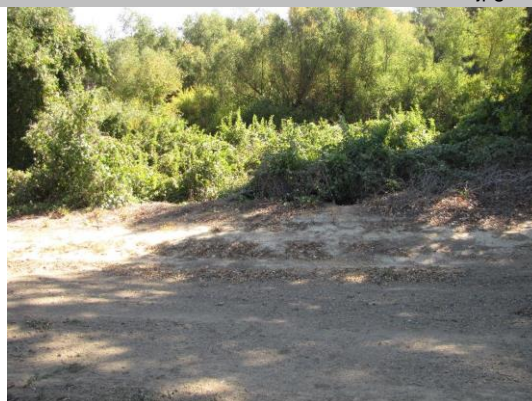
Photo 3 of 3 : UCIP_FA_2019_51855_70083.jpg

Comment Code						
Inspector Comment						
DS_ID:16428 FS_ID:51855 EP_NO: 9467 Repair Type: Non-Urgent Crossing Status: Found UCIP Comments: 5/3/2017 Abandoned- needs to be done so properly. (DWR Sutter Yard- A Freitag)10/24/2016 Abandoned.(DWR Sutter Yard- A Freitag)4/25/2016 Abandoned crossing. Unable to locate any WS and LS pipe ends.4/20/2015 Same as last inspection.6/18/2014 Same as last inspection.12/17/2013 Same as last inspection.7/18/2013 Same as last inspection.10/18/2012 Only riser visible. Debris and sediment blocking gate. Gate inside riser is buried and non-functional. If crossing is abandoned, owner needs to properly abandon. This crossing was listed in the USACE Periodic Inspections as ID# USACE_CESPK_MA1C_2010_p_0132 no culvert through the levee is visible here. FIELD_STRUCT_DESC: *ABANDONED* 24-inch corrugated metal drainage pipe through the levee, approximately 12-15 feet below the crown. Slide gate in CM pipe riser on the waterside (WS) slope. No signs of inlet visible on the landside (LS). (24-inch pipe [HLM 2.31] authorized under Automatic Board Order (ABO) issued as Permit No. 9467, 1974 - Lovell E. Spurgeon) [Additional Reference(s): DWR Levee Log, 1992. USACE Sacramento O&M Manual 137, August 1955, (Station 120+60)]. FS Date: 5/19/2017 1:48:04 PM

Unable to locate WS outlet.

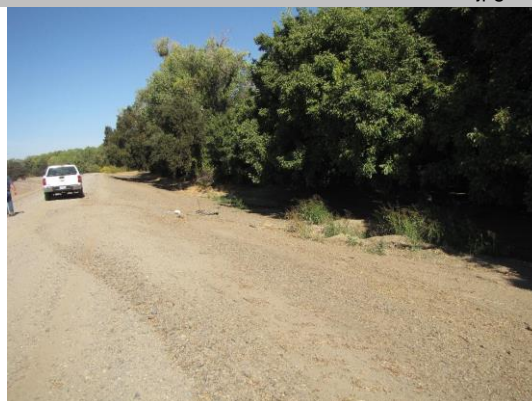
Photo 2 of 3 : UCIP_FA_2019_51859_70109.jpg

DS_ID:16426
FS_ID:51859
EP_NO: 9490
Repair Type: Non-Urgent
Crossing Status: Found
UCIP Comments: 5/3/2017 Sediment build up in WS pipe end. WS slide gate stem bent but it does not affect its operation. (DWR Sutter Yard- A Freitag)10/24/2016 WS slide gate stem is still bent.(DWR Sutter Yard- A Freitag)4/25/2016 WS slide gate is slightly bent. Rest of crossing appears to be in good condition. 4/20/2015 LS inlet still has some minor sediment build up. Needs to be cleaned.6/18/2014 Same as last inspection.12/17/2013 Same as last inspection.7/18/2013 WS slide gate looks to be in good condition but stem is slightly bent. Not sure if bend will hinder gates operation or not. LS inlet is still blocked by minor sediment build up.10/18/2012 LS pipe slightly deformed and sediment build up blocking about 30% of opening; need to check the condition of the slide gate-need photo. Metal marker down. This crossing was listed in the USACE Periodic Inspection as ID# USACE_CESPK_MA1C_2010_p_0187 for sediment build up at landward toe.

View of WS looking upstream.

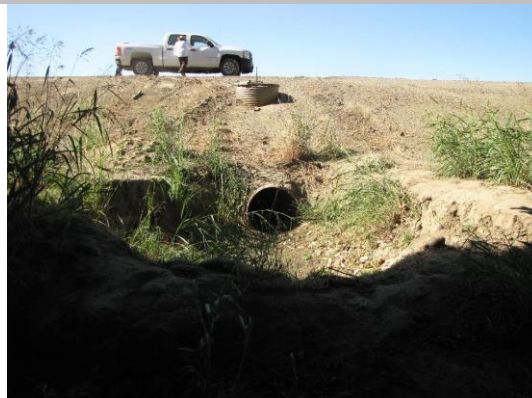
Photo 3 of 3 : UCIP_FA_2019_51859_70111.jpg

Item	DRAFT DWR UCIP LMA Responsibility		39.250843 °	39.250843 °								
			-122.007992 °	-122.007992 °								
DWR ID	16426											
Comment Code												
Inspector Comment												
DS_ID:16426 FS_ID:51859 EP_NO: 9490 Repair Type: Non-Urgent Crossing Status: Found UCIP Comments: 5/3/2017 Sediment build up in WS pipe end. WS slide gate stem bent but it does not affect its operation. (DWR Sutter Yard- A Freitag)10/24/2016 WS slide gate stem is still bent.(DWR Sutter Yard- A Freitag)4/25/2016 WS slide gate is slightly bent. Rest of crossing appears to be in good condition. 4/20/2015 LS inlet still has some minor sediment build up. Needs to be cleaned.6/18/2014 Same as last inspection.12/17/2013 Same as last inspection.7/18/2013 WS slide gate looks to be in good condition but stem is slightly bent. Not sure if bend will hinder gates operation or not. LS inlet is still blocked by minor sediment build up.10/18/2012 LS pipe slightly deformed and sediment build up blocking about 30% of opening; need to check the condition of the slide gate-need photo. Metal marker down. This crossing was listed in the USACE Periodic Inspection as ID# USACE_CESPK_MA1C_2010_p_0187 for sediment build up at landward toe. FIELD_STRUCT_DESC: 36-inch corrugated metal drainage pipe through the levee, approximately 12-15 feet below the crown. Slide gate in corrugated metal pipe (CMP) riser on the waterside (WS) slope. (36-inch pipe [HLM 3.78] authorized under Automatic Board Order (ABO) issued as Permit No. 9490, 1955 - Charles & Virginia Yerxa) [Additional Reference(s): DWR Levee Log, 1992. USACE Sacramento O&M Manual 137, August 1955, (Station 177+67)]. FS Date: 5/19/2017 1:53:31 PM

View of WS slope, riser with slide gate, and outlet.

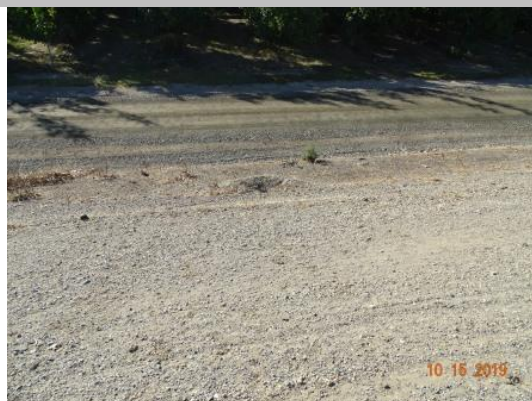
Photo 1 of 1 : FA_2019_MA0001_297_80_20191017_00150.jpg

View of the rodent activity at the landside toe. Fall 2019.

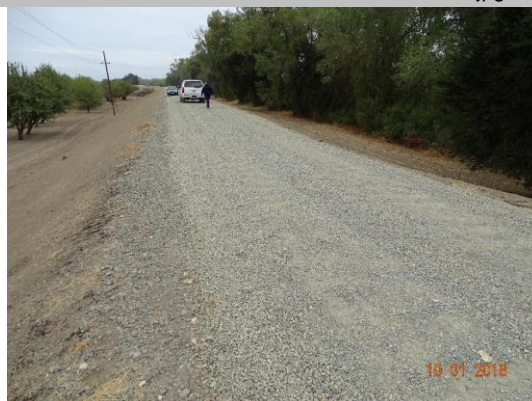
Photo 1 of 3 : UCIP_FA_2019_53049_78240.jpg

UCIP Comments: 10/1/2018 PVC pipe underneath the slide gate that is located inside CMP riser on WS shoulder was restored and blocks gate from closing. Sediment built up at the bottom of CMP riser. PVC pipe needs to be removed in order to properly close slide gate. (O.Yakimov - DWR UCIP)5/3/2017 Pipe leaked during the Jan/Feb 2017 high water event. Sand bags were placed at both the LS and WS outlets as well as down inside the standpipe to slow the water flow. The 5inch pvc was cut away but the slide gate could still not close fully. Suspect sediment build up was in the bottom of the stand pipe was blocking the gate. Inside of pipe should be cleaned out. (DWR Sutter Yard-AFreitag)10/24/2016 Pvc was back running through the crossing and blocking the screwgate. photo attached(DWR Sutter Yard-AFreitag)9/28/2016 Crossing has been downgraded from Urgent to Non-Urgent 5-inch PVC pipe was cut to allow the slide gate to close. Need to contact owner to remove unauthorized pipe to comply with Title 23. (DWR UCIP - omagana)4/25/2016 5 inch pvc pipe running through crossing has been cut out to allow the slide gate to close. (DWR Sutter Yard - afreitag)4/20/2015 5inch pvc is still present blocking slide gate from closing. WS end of pipe has been exposed so there is no way to stop water from flowing through pipe during highwater times. (DWR Sutter Yard - afreitag)6/23/2014 Same as last inspection. There is no way to stop water from flowing through pipe during high water times. (DWR Sutter Yard - afreitag)12/17/2013 Same as last inspection. (DWR Sutter Yard - afreitag)7/18/2013 Same as last inspection. (DWR Sutter Yard - afreitag)10/19/2012 Unauthorized 5 inch PVC pipe running through 36 inch crossing. 5 inch PVC crossing prevents slide gate from closing during high water. Debris and sediment inside riser. This crossing was listed in the USACE Periodic Inspection as ID# USACE_CESPK_MA1C_2010_p_0258 for 5 inch PVC pipe running through culvert. (DWR UCIP - omagana) FIELD_STRUCT_DESC: 36-inch steel (not corrugated metal, as referenced in O&M manual) drainage pipe through the levee, approximately 14-16 feet below levee crown. Slide gate in corrugated metal pipe (CMP) riser on the waterside (WS) slope. Pipe also visible on the landside (LS). [Additional Reference(s): DWR Levee Log, 1992. USACE Sacramento O&M Manual 137, August 1955, (Station 331+31)]. FS Date: 10/1/2018 2:59:44 PM

View of levee crown at crossing.

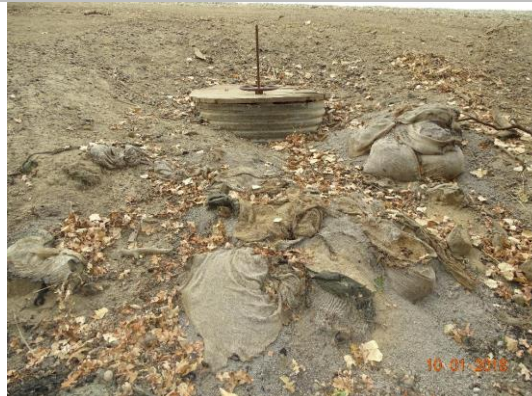
Photo 2 of 3 : UCIP_FA_2019_53049_78243.jpg

UCIP Comments: 10/1/2018 PVC pipe underneath the slide gate that is located inside CMP riser on WS shoulder was restored and blocks gate from closing. Sediment built up at the bottom of CMP riser. PVC pipe needs to be removed in order to properly close slide gate. (O.Yakimov - DWR UCIP)5/3/2017 Pipe leaked during the Jan/Feb 2017 high water event. Sand bags were placed at both the LS and WS outlets as well as down inside the standpipe to slow the water flow. The 5inch pvc was cut away but the slide gate could still not close fully. Suspect sediment build up was in the bottom of the stand pipe was blocking the gate. Inside of pipe should be cleaned out. (DWR Sutter Yard-AFreitag)10/24/2016 Pvc was back running through the crossing and blocking the screwgate. photo attached(DWR Sutter Yard-AFreitag)9/28/2016 Crossing has been downgraded from Urgent to Non-Urgent 5-inch PVC pipe was cut to allow the slide gate to close. Need to contact owner to remove unauthorized pipe to comply with Title 23. (DWR UCIP - omagana)4/25/2016 5 inch pvc pipe running through crossing has been cut out to allow the slide gate to close. (DWR Sutter Yard - afreitag)4/20/2015 5inch pvc is still present blocking slide gate from closing. WS end of pipe has been exposed so there is no way to stop water from flowing through pipe during highwater times. (DWR Sutter Yard - afreitag)6/23/2014 Same as last inspection. There is no way to stop water from flowing though pipe during high water times. (DWR Sutter Yard - afreitag)12/17/2013 Same as last inspection. (DWR Sutter Yard - afreitag)7/18/2013 Same as last inspection. (DWR Sutter Yard - afreitag)10/19/2012 Unauthorized 5 inch PVC pipe running through 36 inch crossing. 5 inch PVC crossing prevents slide gate from closing during high water. Debris and sediment inside riser. This crossing was listed in the USACE Periodic Inspection as ID# USACE_CESPK_MA1C_2010_p_0258 for 5 inch PVC pipe running through culvert. (DWR UCIP - omagana) FIELD_STRUCT_DESC: 36-inch steel (not corrugated metal, as referenced in O&M manual) drainage pipe through the levee, approximately 14-16 feet below levee crown. Slide gate in corrugated metal pipe (CMP) riser on the waterside (WS) slope. Pipe also visible on the landside (LS). [Additional Reference(s): DWR Levee Log, 1992. USACE Sacramento O&M Manual 137, August 1955, (Station 331+31)]. FS Date: 10/1/2018 2:59:44 PM

View of CMP riser at WS shoulder.

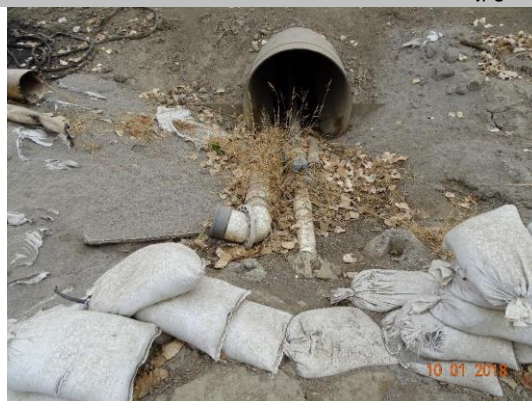
Photo 3 of 3 : UCIP_FA_2019_53049_78244.jpg

UCIP Comments: 10/1/2018 PVC pipe underneath the slide gate that is located inside CMP riser on WS shoulder was restored and blocks gate from closing. Sediment built up at the bottom of CMP riser. PVC pipe needs to be removed in order to properly close slide gate. (O.Yakimov - DWR UCIP)5/3/2017 Pipe leaked during the Jan/Feb 2017 high water event. Sand bags were placed at both the LS and WS outlets as well as down inside the standpipe to slow the water flow. The 5inch pvc was cut away but the slide gate could still not close fully. Suspect sediment build up was in the bottom of the stand pipe was blocking the gate. Inside of pipe should be cleaned out. (DWR Sutter Yard-AFreitag)10/24/2016 Pvc was back running through the crossing and blocking the screwgate. photo attached(DWR Sutter Yard-AFreitag)9/28/2016 Crossing has been downgraded from Urgent to Non-Urgent 5-inch PVC pipe was cut to allow the slide gate to close. Need to contact owner to remove unauthorized pipe to comply with Title 23. (DWR UCIP - omagana)4/25/2016 5 inch pvc pipe running through crossing has been cut out to allow the slide gate to close. (DWR Sutter Yard - afreitag)4/20/2015 5inch pvc is still present blocking slide gate from closing. WS end of pipe has been exposed so there is no way to stop water from flowing through pipe during highwater times. (DWR Sutter Yard - afreitag)6/23/2014 Same as last inspection. There is no way to stop water from flowing through pipe during high water times. (DWR Sutter Yard - afreitag)12/17/2013 Same as last inspection. (DWR Sutter Yard - afreitag)7/18/2013 Same as last inspection. (DWR Sutter Yard - afreitag)10/19/2012 Unauthorized 5 inch PVC pipe running through 36 inch crossing. 5 inch PVC crossing prevents slide gate from closing during high water. Debris and sediment inside riser. This crossing was listed in the USACE Periodic Inspection as ID# USACE_CESPK_MA1C_2010_p_0258 for 5 inch PVC pipe running through culvert. (DWR UCIP - omagana) FIELD_STRUCT_DESC: 36-inch steel (not corrugated metal, as referenced in O&M manual) drainage pipe through the levee, approximately 14-16 feet below levee crown. Slide gate in corrugated metal pipe (CMP) riser on the waterside (WS) slope. Pipe also visible on the landside (LS). [Additional Reference(s): DWR Levee Log, 1992. USACE Sacramento O&M Manual 137, August 1955, (Station 331+31)]. FS Date: 10/1/2018 2:59:44 PM

Pipe at LS toe.

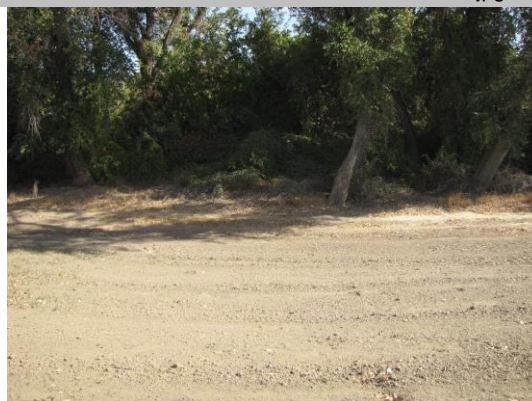
Photo 1 of 3 : UCIP_FA_2019_51874_70181.jpg

Comment Code						
Inspector Comment						
DS_ID:16425 FS_ID:51874 EP_NO: N/A Repair Type: Non-Urgent Crossing Status: Found UCIP Comments: 5/3/2017 Abandoned- needs to be done properly. (DWR Sutter Yard- AFreitag)10/24/2016 Abandoned(DWR Sutter Yard- AFreitag)4/25/2016 Abandoned crossing.4/20/2015 Same as last inspection.6/23/2014 Same as last inspection.12/17/2013 Same as last inspection.7/18/2013 Same as last inspection.10/19/2012 Need to be properly abandoned concrete structure; plate covers concrete box; Concrete headwall damaged. This crossing was listed in the USACE Periodic Inspection as ID# USACE_CESPK_MA1C_2010_p_0262 for damage to concrete structure (vertical 2 inch wide cracks and spalling visible). FIELD_STRUCT_DESC: *ABANDONED* 72-inch corrugated metal (precast concrete) drainage pipe through the levee at an unknown depth below the crown. Structure is blocked on the waterside (WS) end with 3-foot concrete plug installed in 1980. Slide gate in concrete well on the landside (LS) shoulder. Concrete headwall at both toes. WS headwall not found. [Additional Reference(s): DWR Levee Log, 1992. USACE Sacramento O&M Manual 137, August 1955, (Station 339+74)]. FS Date: 5/23/2017 10:13:24 AM

View of WS no structure features visible.

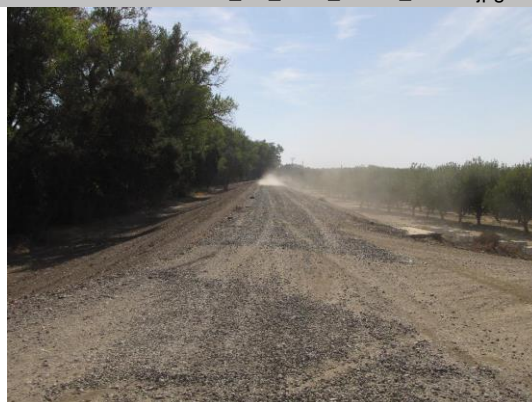
Photo 2 of 3 : UCIP_FA_2019_51874_70180.jpg

Overview of levee crown looking downstream at crossing.

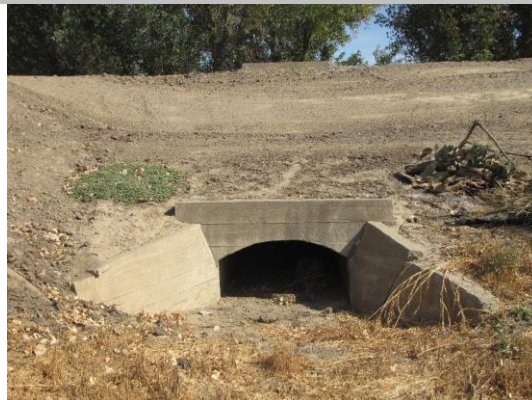
Photo 3 of 3 : UCIP_FA_2019_51874_70179.jpg

Comment Code						
Inspector Comment						
DS_ID:16425 FS_ID:51874 EP_NO: N/A Repair Type: Non-Urgent Crossing Status: Found UCIP Comments: 5/3/2017 Abandoned- needs to be done properly. (DWR Sutter Yard- A Freitag)10/24/2016 Abandoned(DWR Sutter Yard- A Freitag)4/25/2016 Abandoned crossing.4/20/2015 Same as last inspection.6/23/2014 Same as last inspection.12/17/2013 Same as last inspection.7/18/2013 Same as last inspection.10/19/2012 Need to be properly abandoned concrete structure; plate covers concrete box; Concrete headwall damaged. This crossing was listed in the USACE Periodic Inspection as ID# USACE_CESPK_MA1C_2010_p_0262 for damage to concrete structure (vertical 2 inch wide cracks and spalling visible). FIELD_STRUCT_DESC: *ABANDONED* 72-inch corrugated metal (precast concrete) drainage pipe through the levee at an unknown depth below the crown. Structure is blocked on the waterside (WS) end with 3-foot concrete plug installed in 1980. Slide gate in concrete well on the landside (LS) shoulder. Concrete headwall at both toes. WS headwall not found. [Additional Reference(s): DWR Levee Log, 1992. USACE Sacramento O&M Manual 137, August 1955, (Station 339+74)]. FS Date: 5/23/2017 10:13:24 AM

View of structure located in LS.

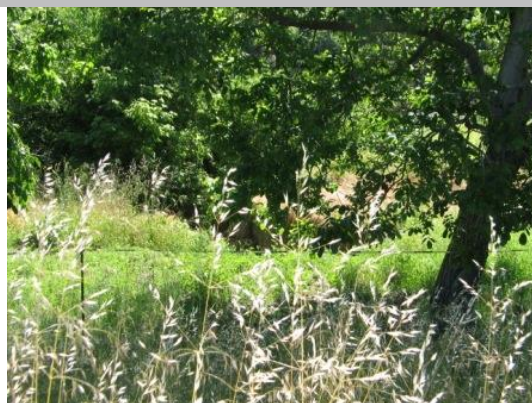
Photo 1 of 1 : FA_2019_MA0001_297_18_20190822_00008.jpg

View of the erosion along the waterside of the levee.

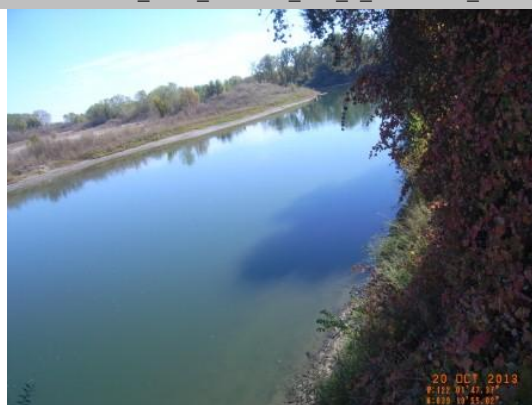
Photo 1 of 1 : FA_2019_MA0001_297_6_20190822_00003.jpg

LM Start	10.32	Rating **	A/W	Issue No.	6
LM End	10.41	Issue Type +	Ma	Location *	WS
Category	Supplemental			GPS Latitude/Longitude	
				Start	End
Item	2017 USACE Erosion Survey			39.331447°	39.332716°
				-122.029440°	-122.029953°
DWR ID	DWR_ST0003_01_f_2018_1				
Comment Code					
Inspector Comment					
2017 Site ID: SAC 157.7 R					
Status: Eroding					
2017 Field Notes: Vertical face of clay sand bank, new tree popout.					
Bank continues to erode.					
Site History: 2004 - Slowly eroding but near vertical with no vegetation to hold it. 2005 - Erosion is close to levee toe but not into the levee section yet. 2010 - Some new toe scour.

USACE 2013 Photo #1

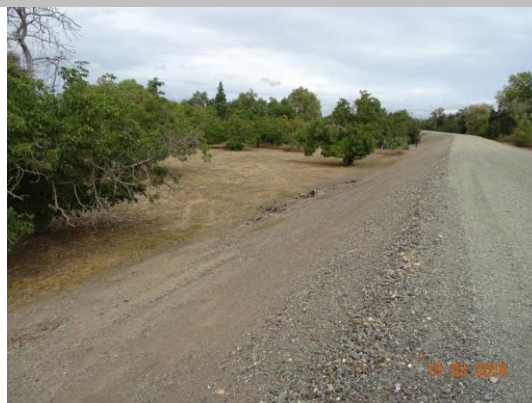
Photo 1 of 1 : FA_2019_MA0001_297_71_20190822_00015.jpg

View of the rodent holes along the landside slope.

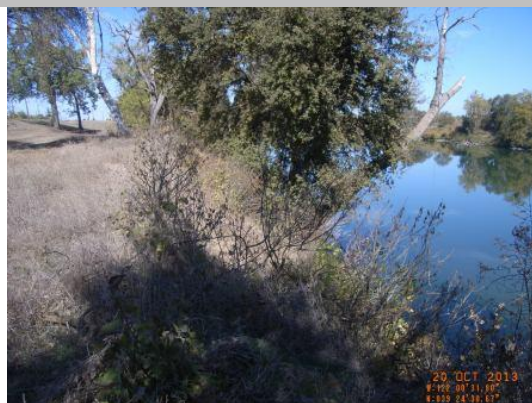
Photo 1 of 2 : FA_2019_MA0001_297_9_20190822_00005.jpg

LM Start	16.35	Rating **	A/W	Issue No.	9
LM End	16.58	Issue Type +	Ma	Location *	WS
Category	Supplemental			GPS Latitude/Longitude	
				Start	End
Item	2017 USACE Erosion Survey			39.407837 °	39.411111 °
				-122.008763 °	-122.009238 °
DWR ID	DWR_ST0010_02_f_2022_7				
Comment Code					
Inspector Comment					
2017 Site ID: SAC 164.3 R					
Status: Eroding					
2017 Field Notes: New erosion along entire site.					
Site History: Erosion site added in 1997 and removed in 2005. 2009 -					
Site added back in, hard toe with slow moving erosion. Potential					
geotechnical failure. 2011 - Site extended downstream.

USACE 2013 Photo #1

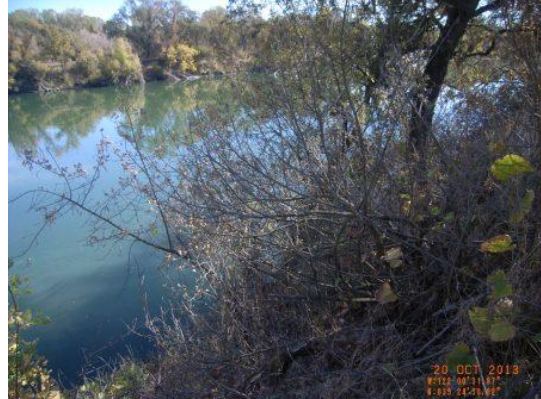
Photo 2 of 2 : FA_2019_MA0001_297_9_20190822_00006.jpg

LM Start	16.35	Rating **	A/W	Issue No.	9 (cont)	
LM End	16.58	Issue Type +	Ma	Location *	WS	
Category	Supplemental			GPS Latitude/Longitude		
				Start	End	
Item	2017 USACE Erosion Survey			39.407837°	39.411111°	
				-122.008763°	-122.009238°	
DWR ID	DWR_ST0010_02_f_2022_7					
Comment Code						
Inspector Comment						
2017 Site ID: SAC 164.3 R						
Status: Eroding						
2017 Field Notes: New erosion along entire site.						
Site History: Erosion site added in 1997 and removed in 2005. 2009 -						
Site added back in, hard toe with slow moving erosion. Potential						
geotechnical failure. 2011 - Site extended downstream.

USACE 2013 Photo #2
